**EMERGENCY STRUCTURAL ASSESSMENT
OF
EARTHQUAKE DAMAGE TO KAILUA - KONA WHARF
LOCATED AT
KAILUA - KONA, HAWAII

PREPARED FOR
THE STATE OF HAWAII
DEPARTMENT OF LAND AND NATURAL RESOURCES
DIVISION OF BOATING AND OCEAN RECREATION
HONOLULU, HAWAII 96813**

**ARNOLD T. OKUBO & ASSOCIATES, INC.
94-529 UKEE STREET, SUITE 107
WAIPAHU, HAWAII 96797**

NOVEMBER 2006

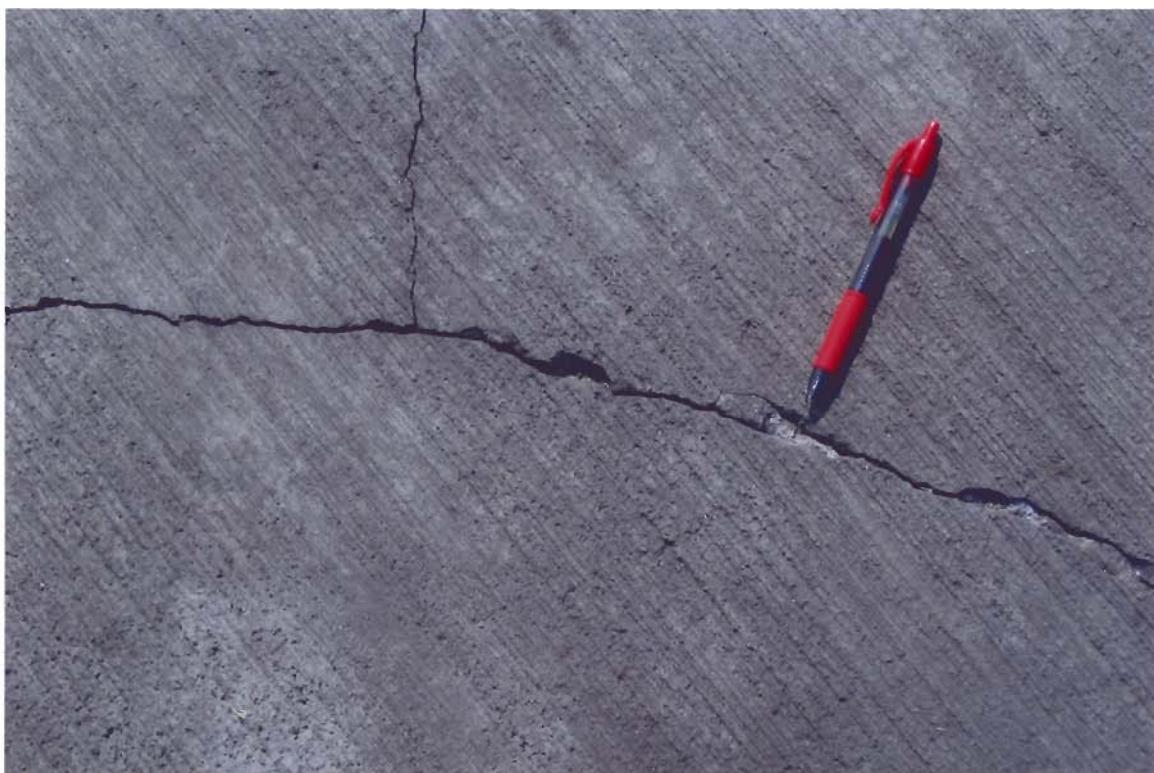
35

South End - Close-up view
of cracks on slab

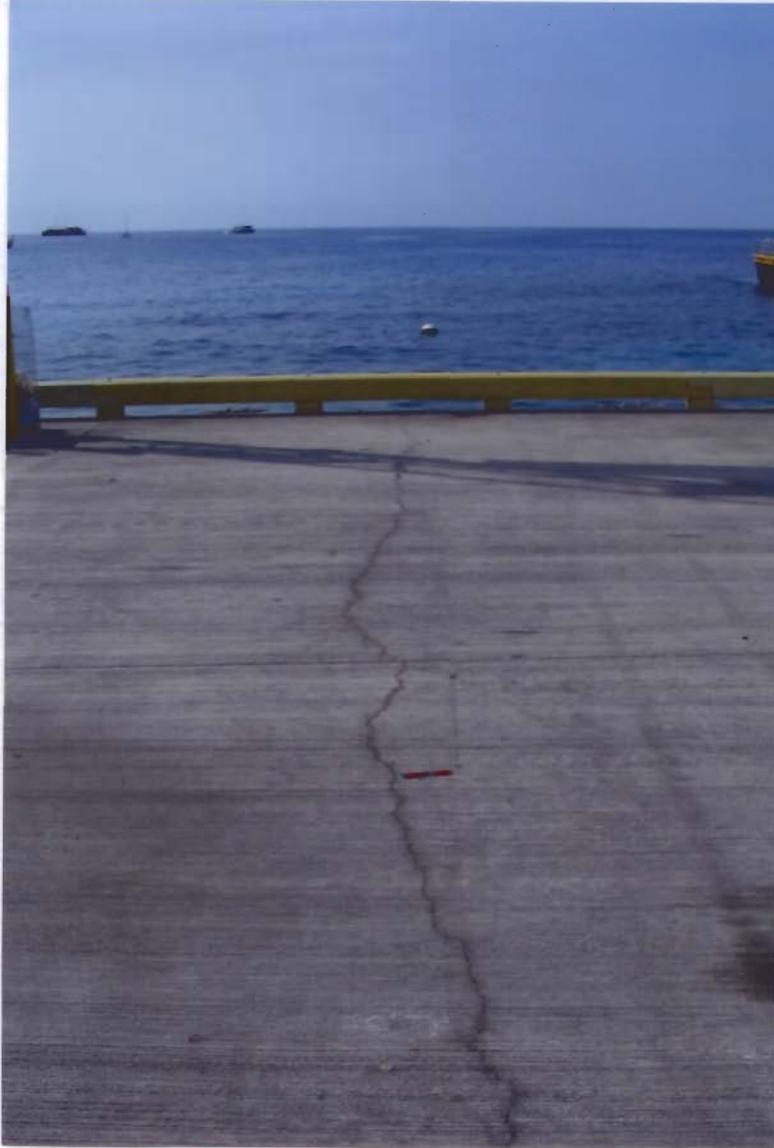
36

South End of Wharf -
Typical cracks on slab
throughout deck area

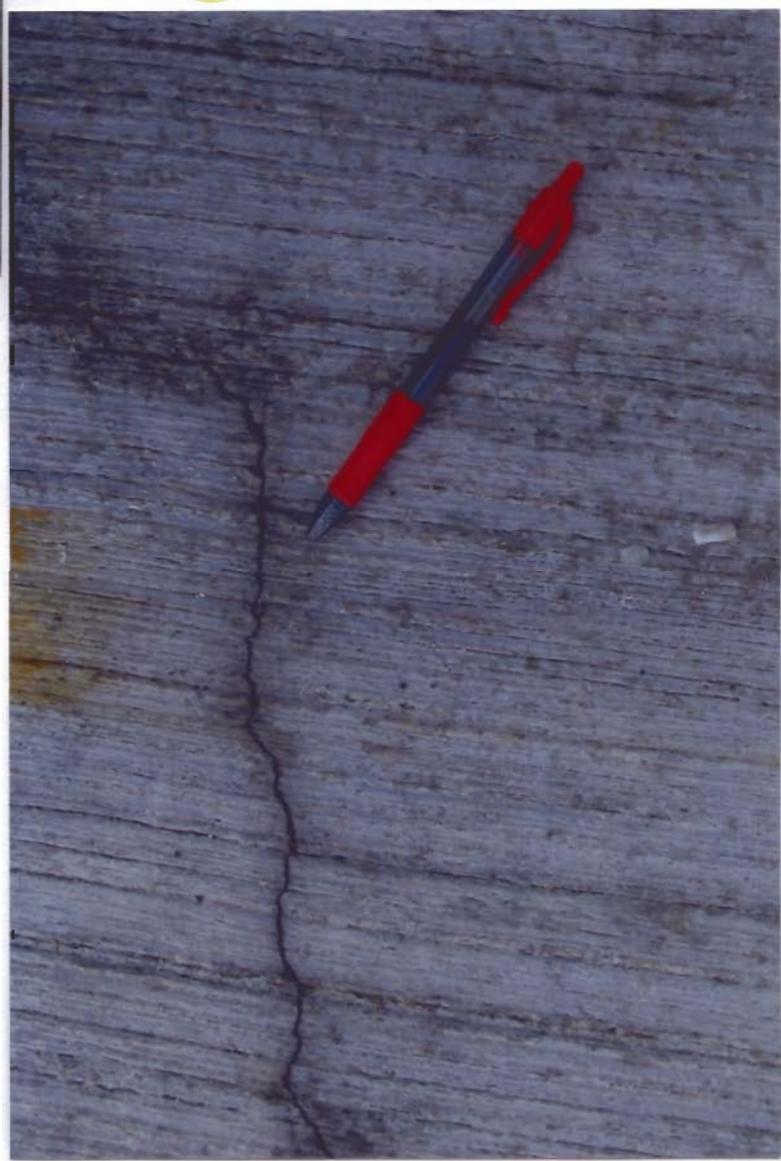
38

Close-up view
of cracks on
slab area

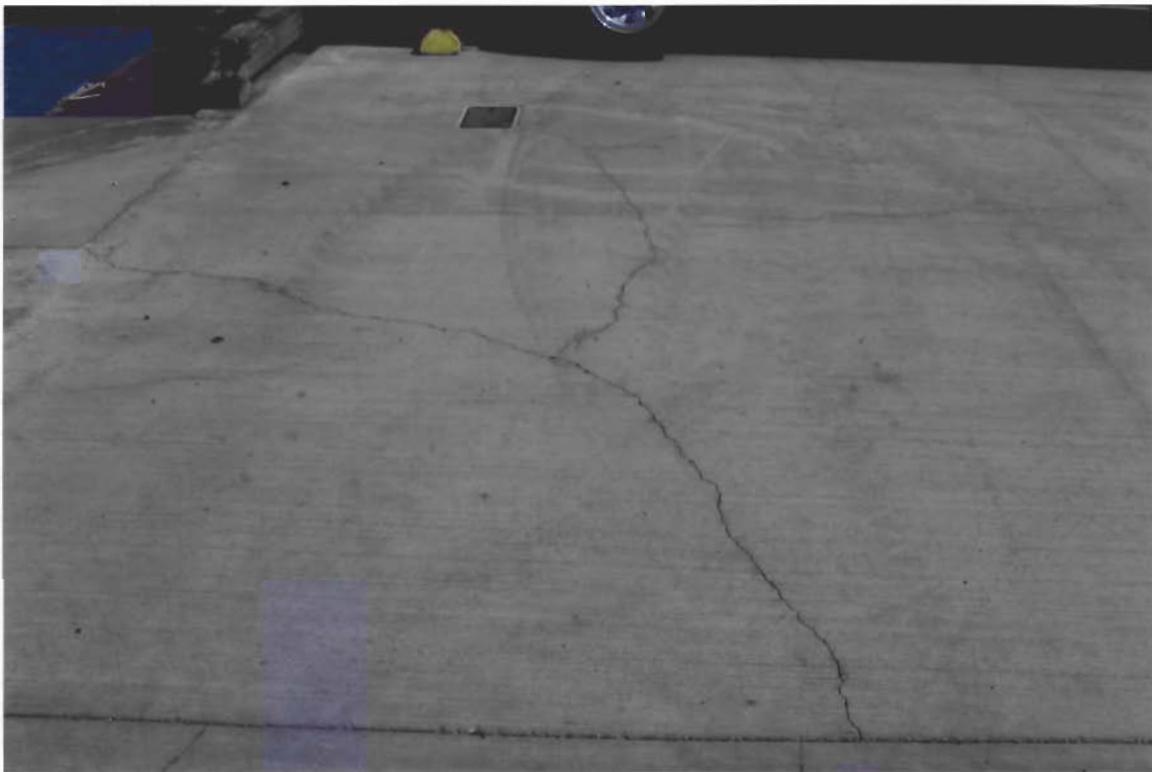
39 South End - Cracks on deck slab

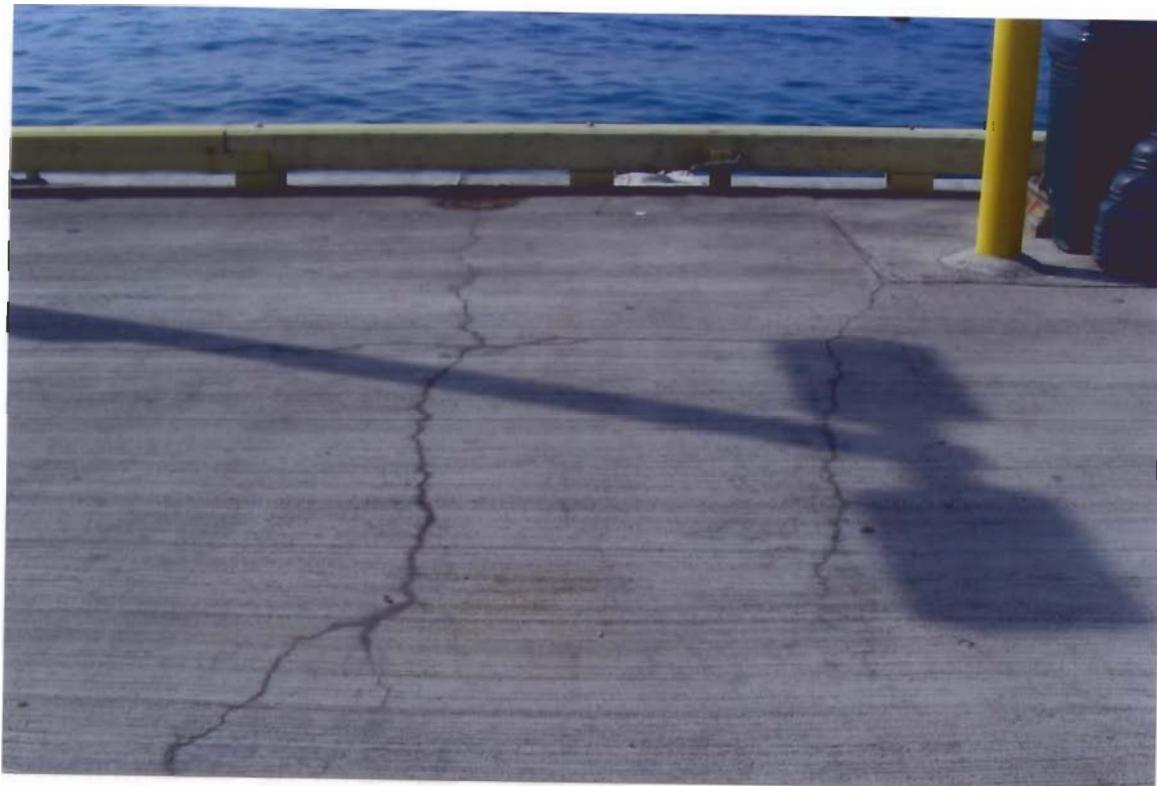
40 South End - Cracks on deck
slab throughout

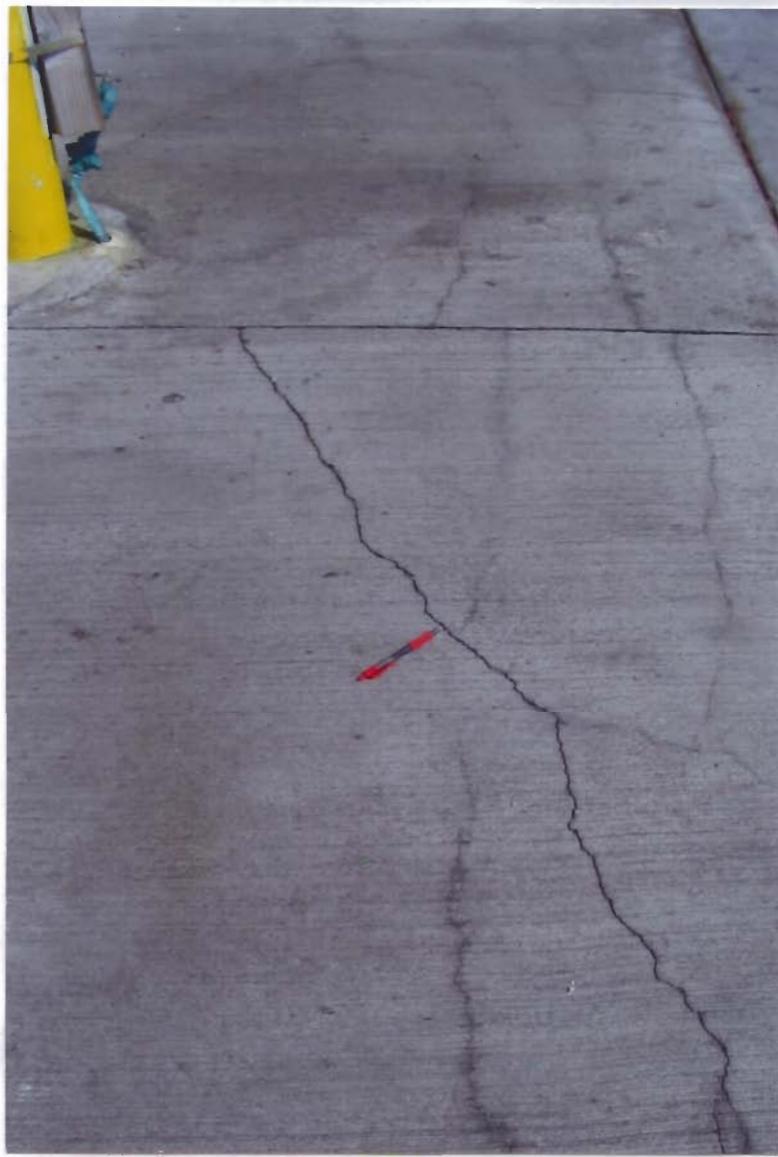
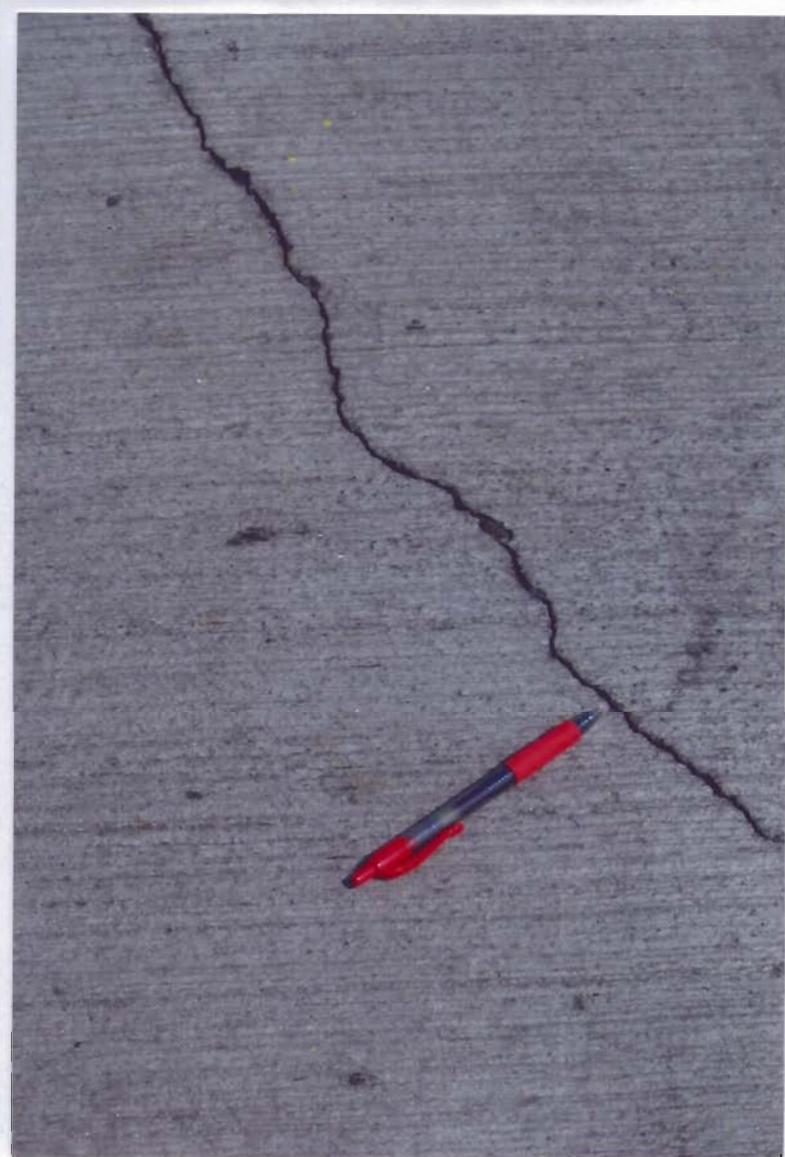
41

South End - Typical cracks throughout on deck slab

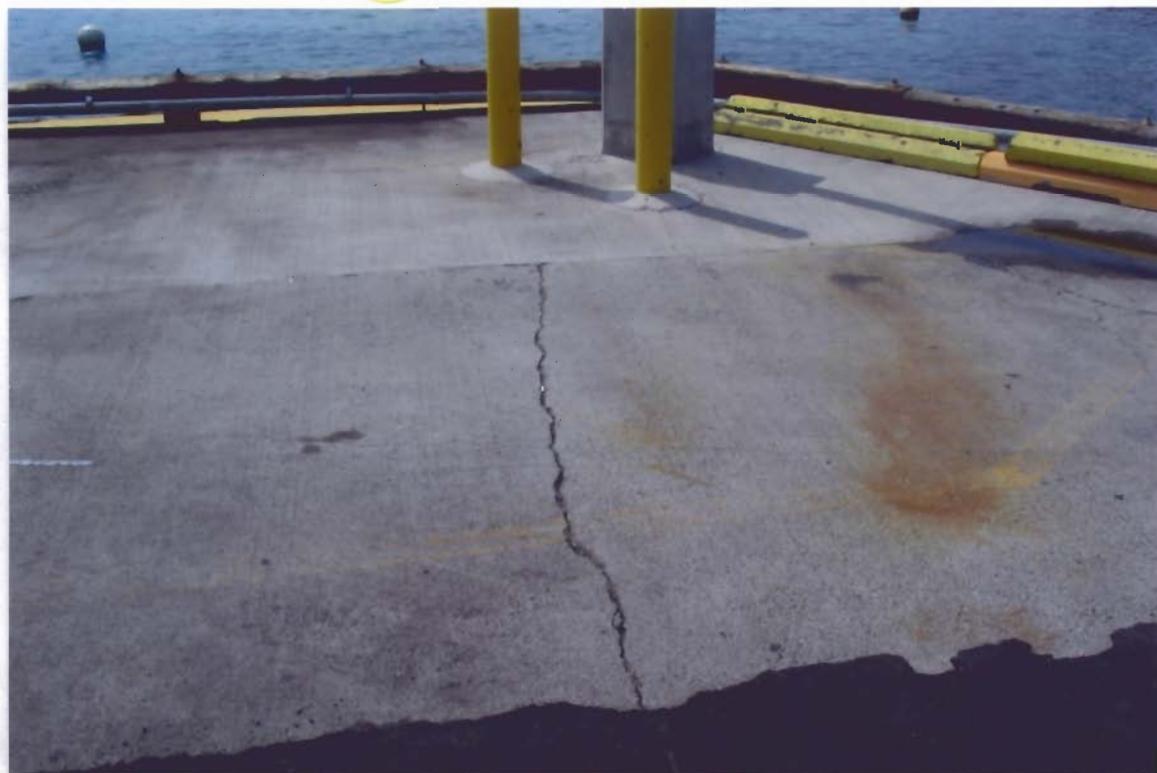
42

South End - Cracks on deck slab

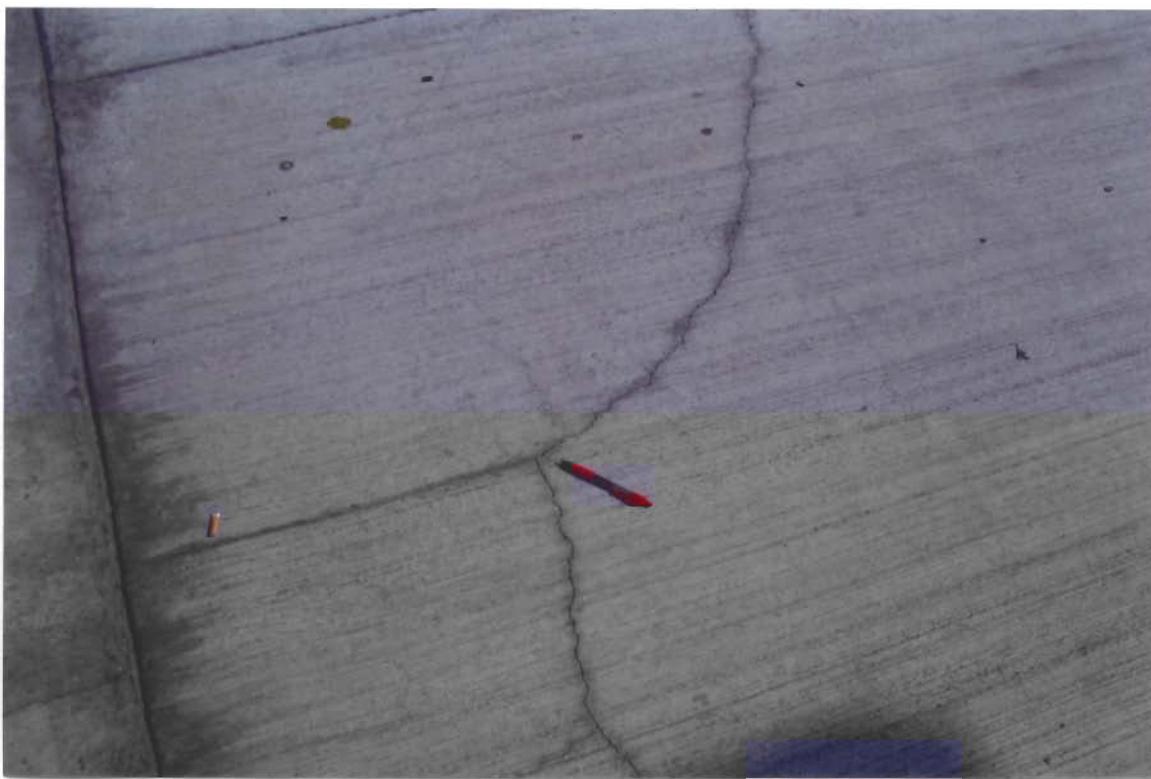
44

South West Side - Close-up
view of cracks on slab

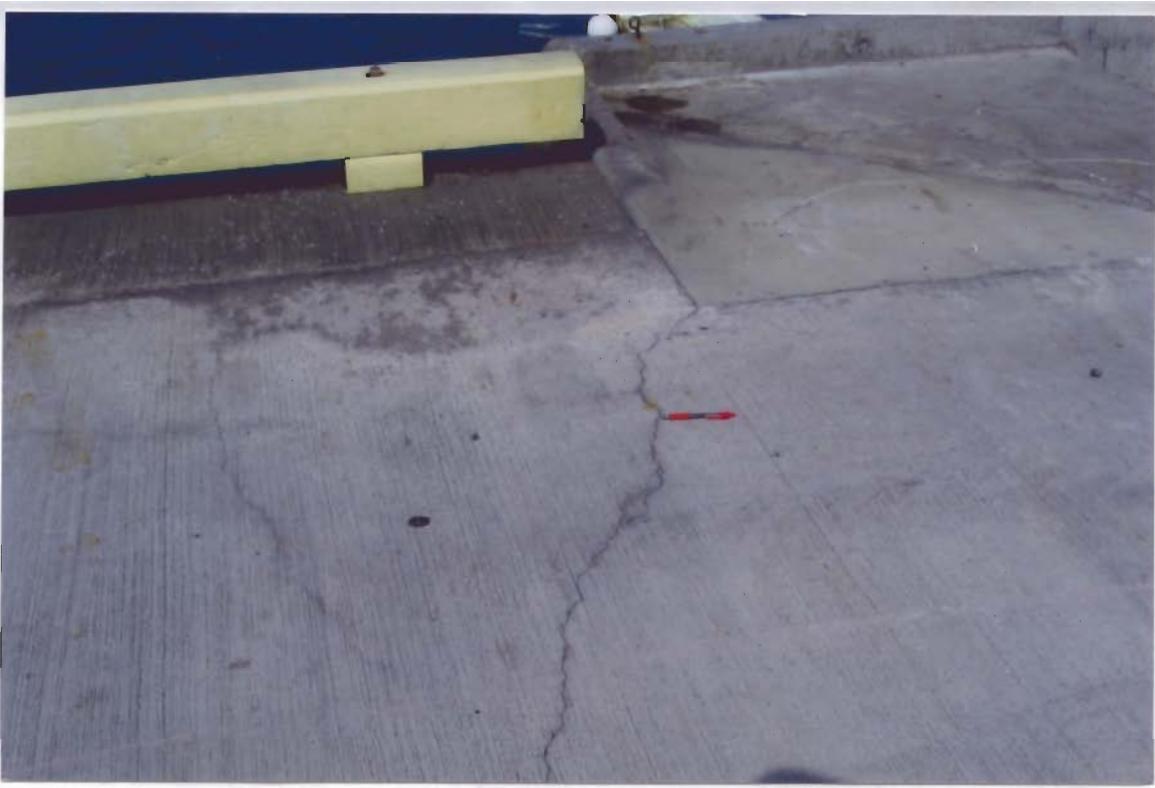
45

South Side - Cracks on slab
throughout deck area

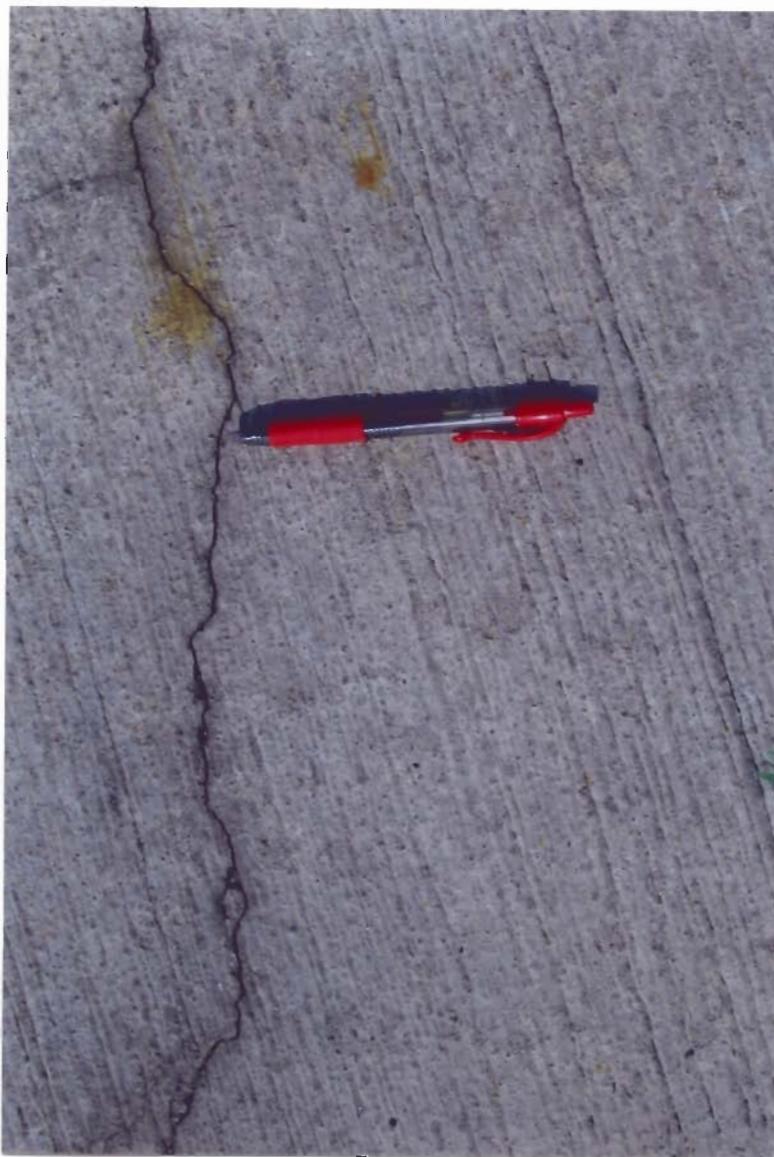
46

South End - Close-up
view of cracks on slab

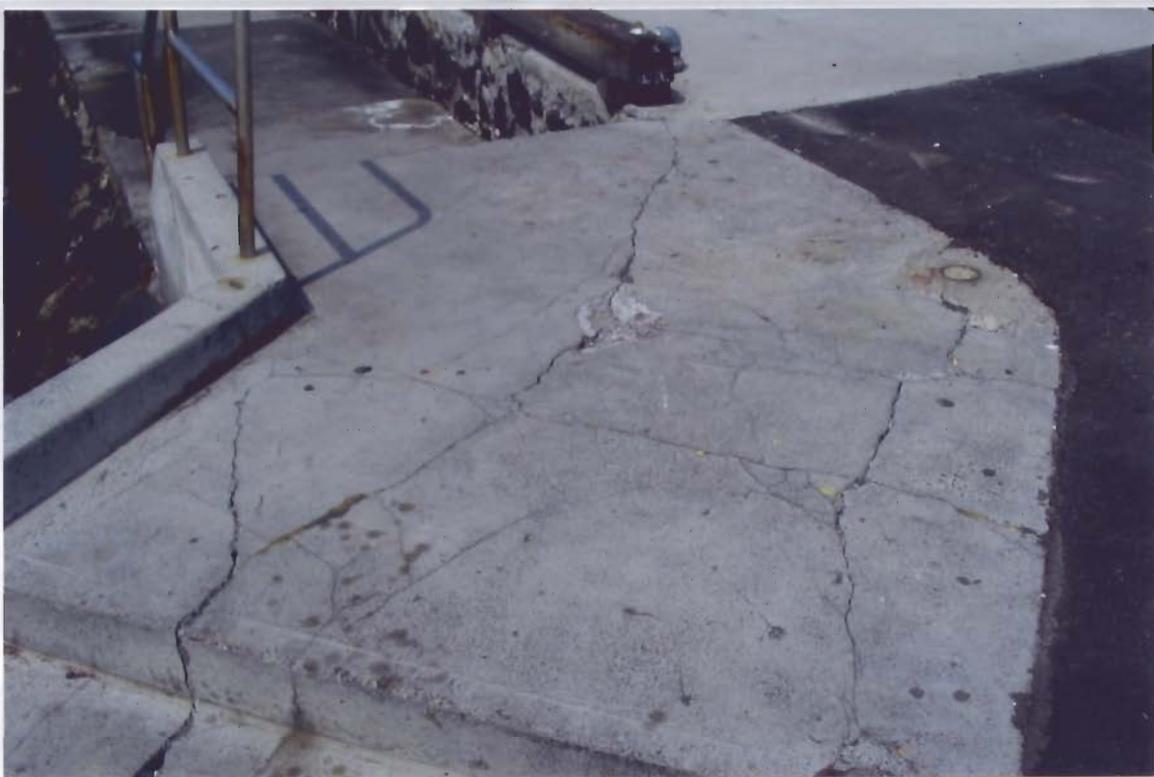
49

West Side
Stair/Landing
cracks @
Loading Dock
No. 4

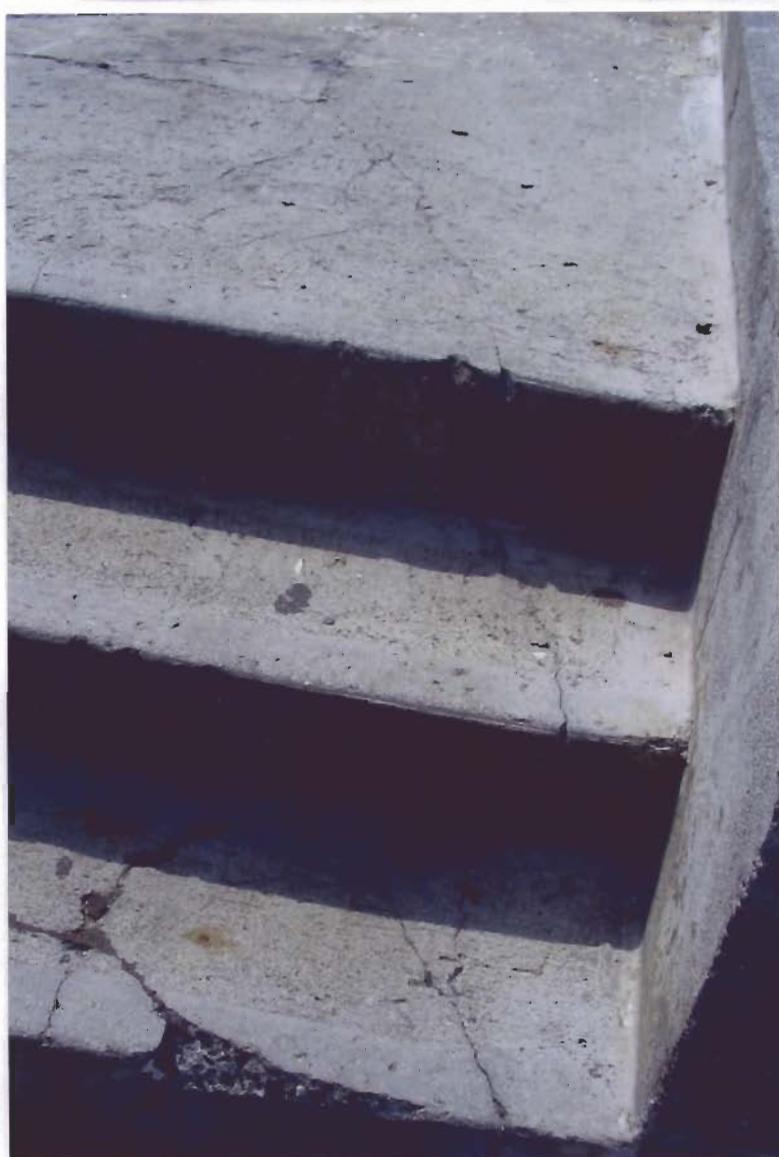
50

Stair cracks @
Loading Dock No. 4

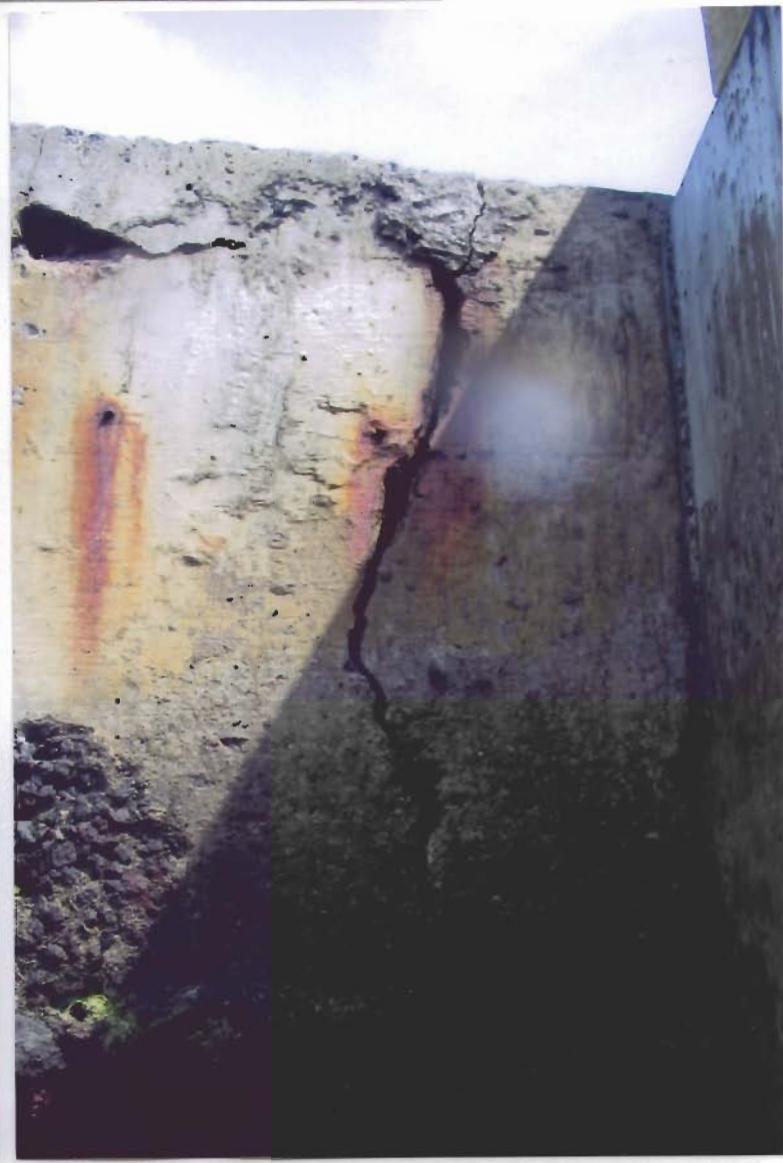
51

Stair landing @ Loading
Dock No. 4 - Cracks on wall

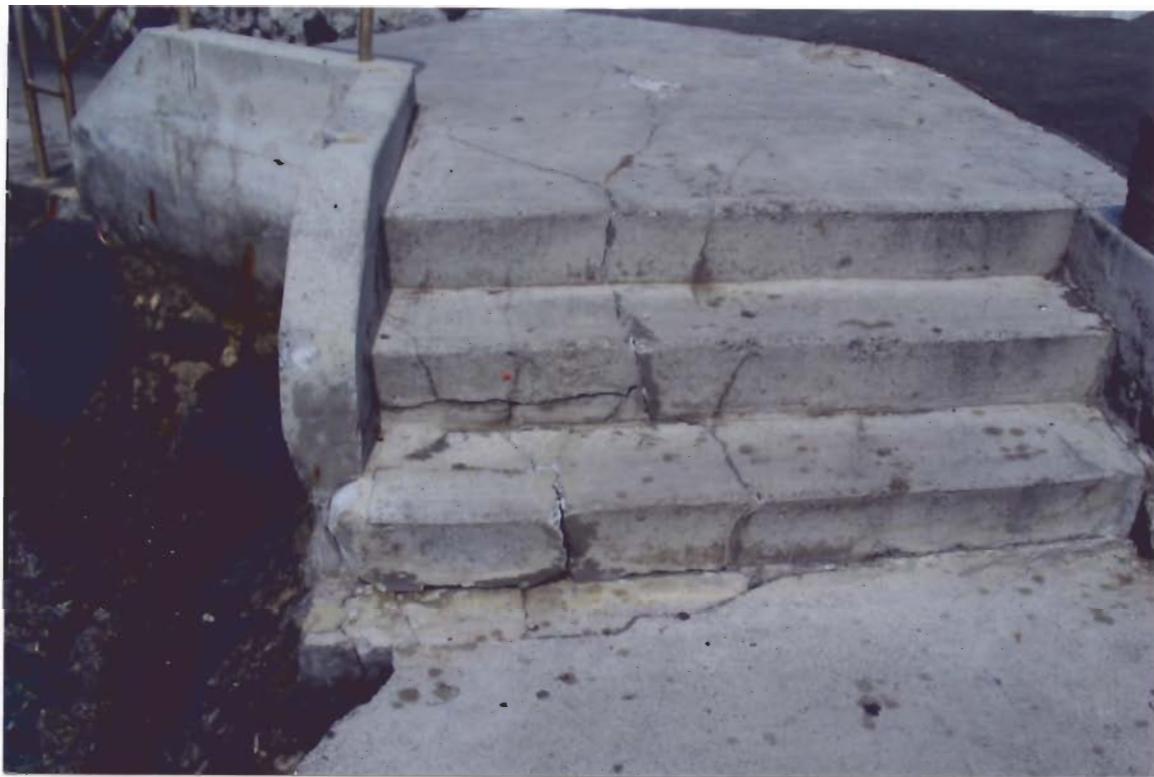
52

Stairway/Landing @ Loading Dock
No. 4 - Cracks at stairway

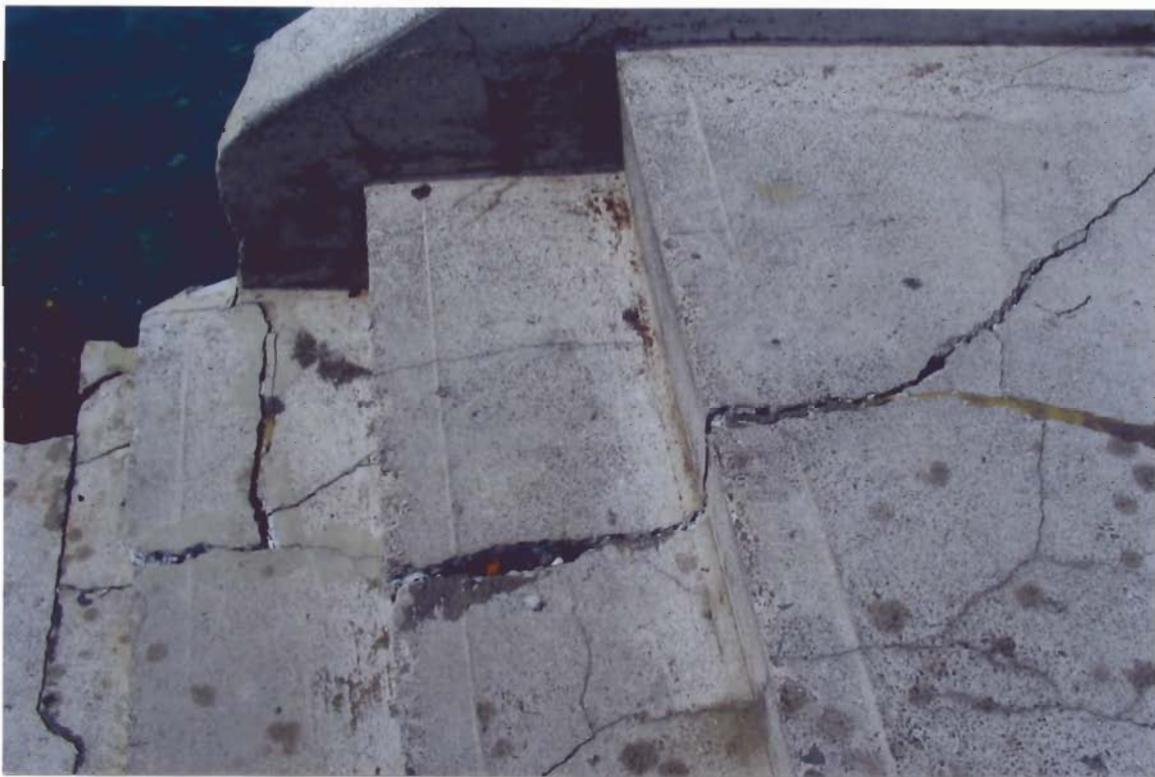
53

Stairway/Landing @ Loading Dock
No. 4 - Cracks at stairway

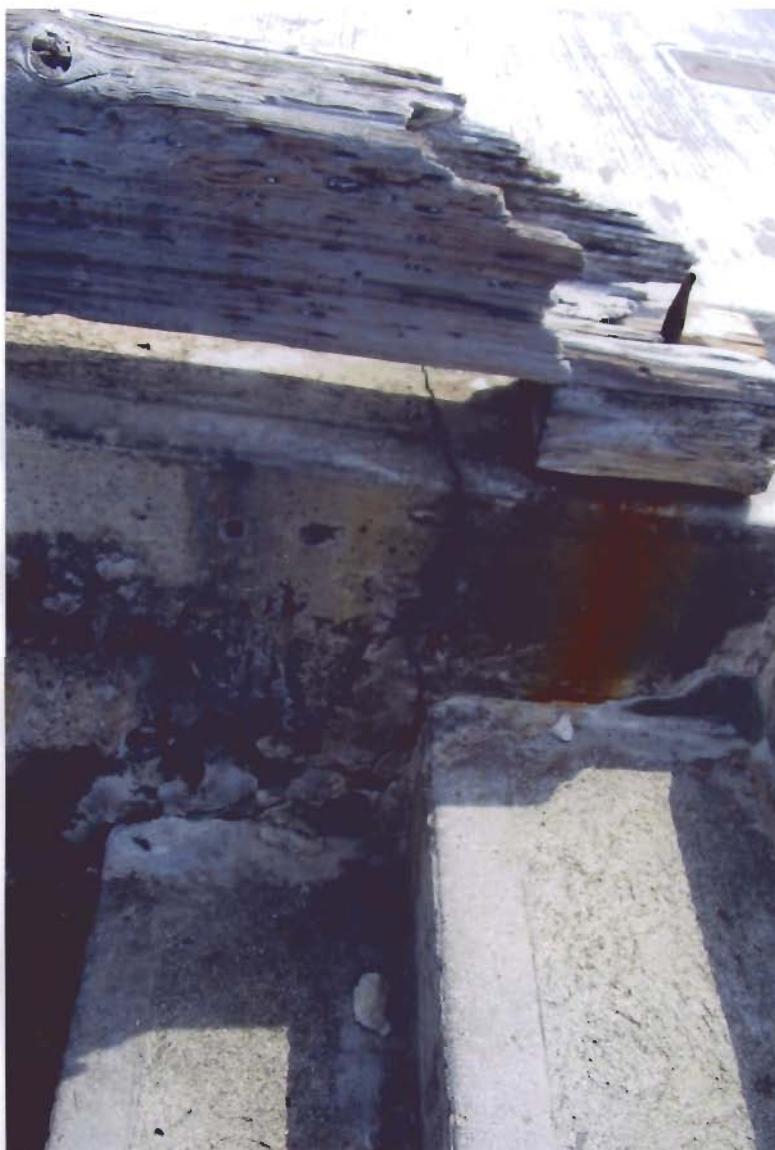
54

Cracks - Stairway @
Loading Dock No. 4

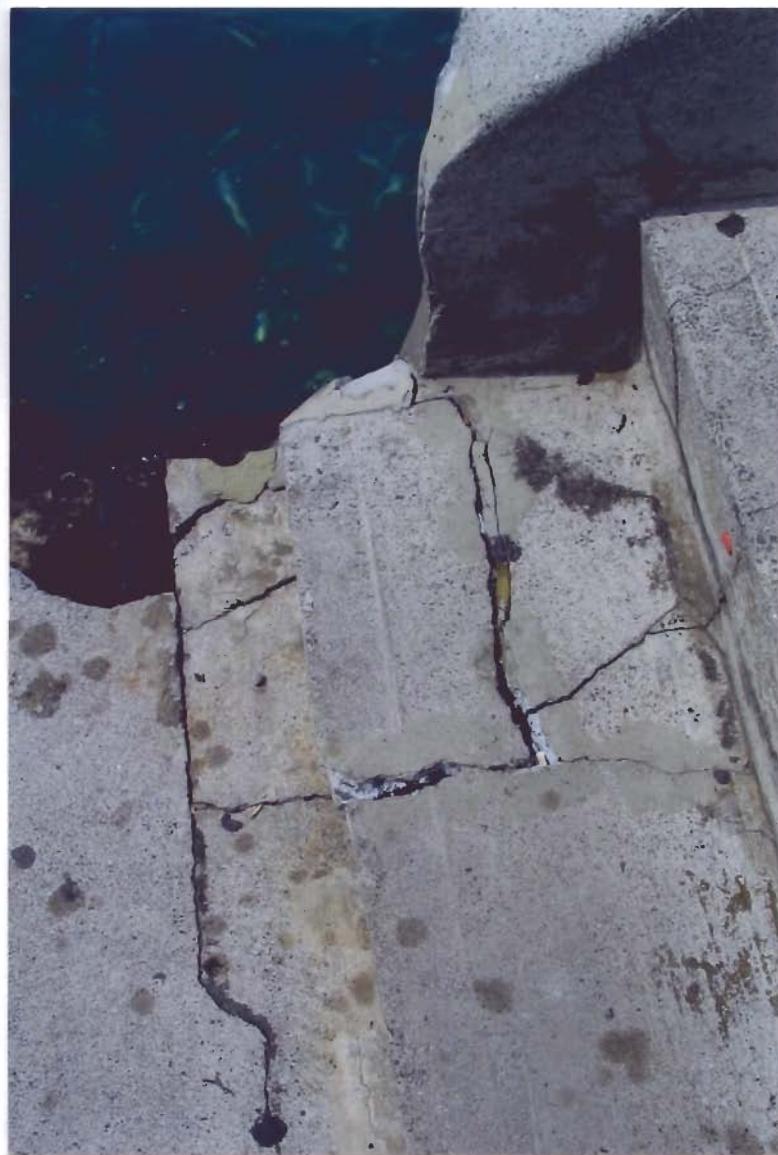
55

Cracks - Stairway @
Loading Dock No. 4

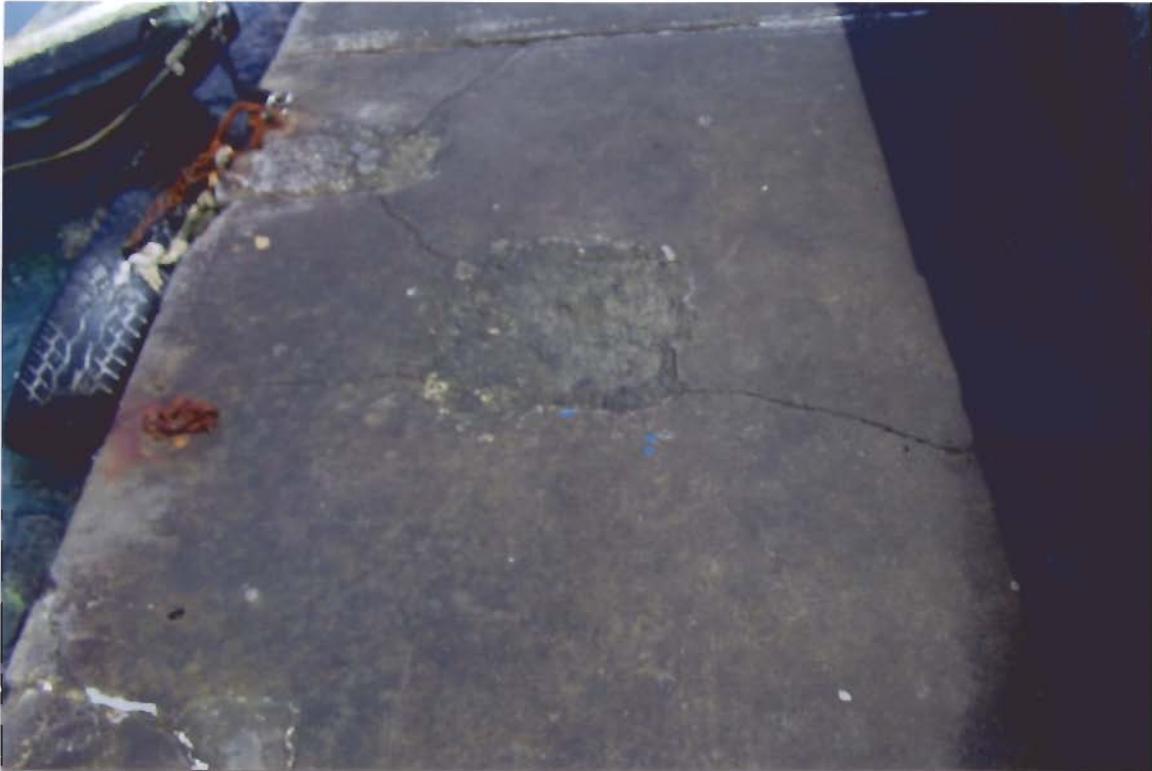
56 Loading Dock No. 4 -
Slab cracks throughout

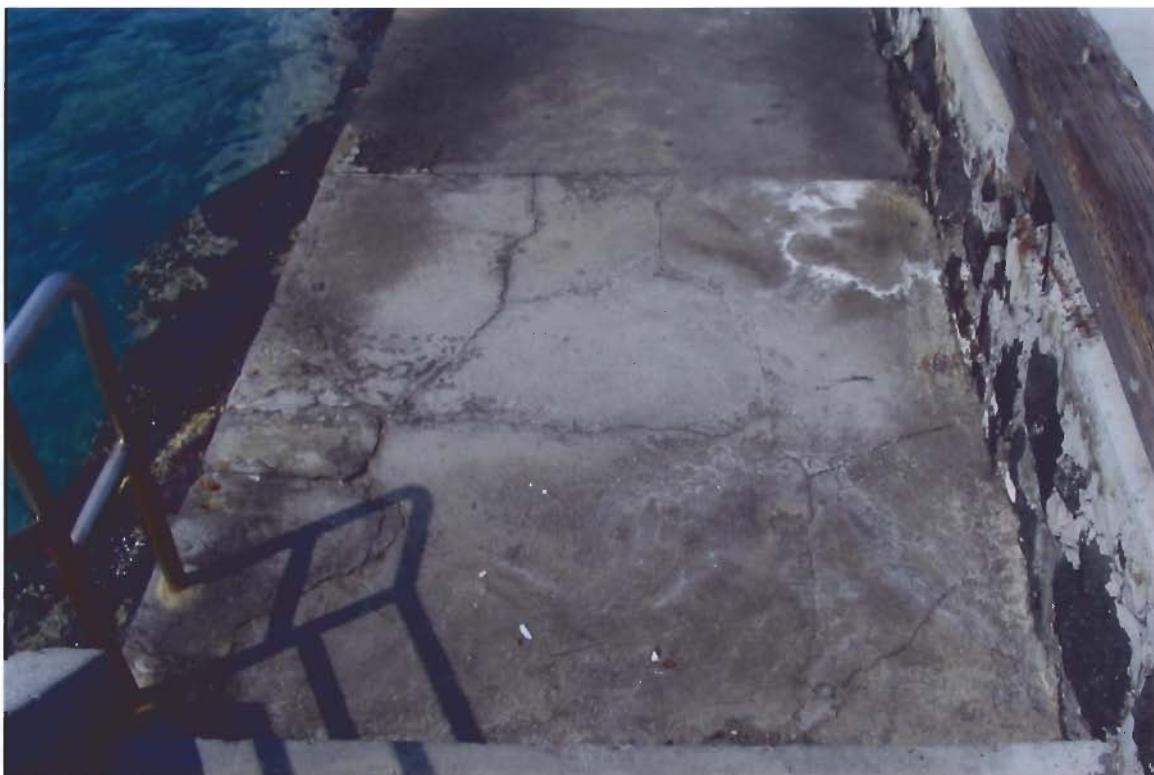
57 Loading Dock No. 4 -
Slab cracks throughout

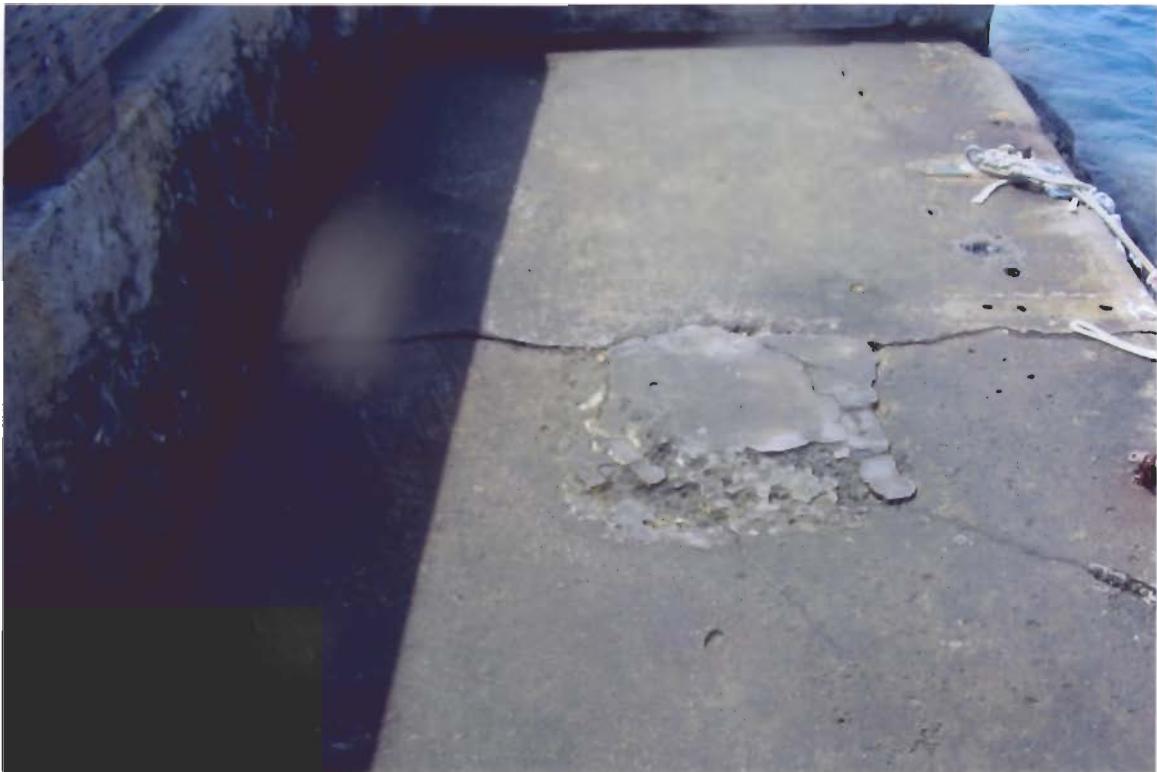
58

Loading Dock No. 4 -
Slab cracks throughout

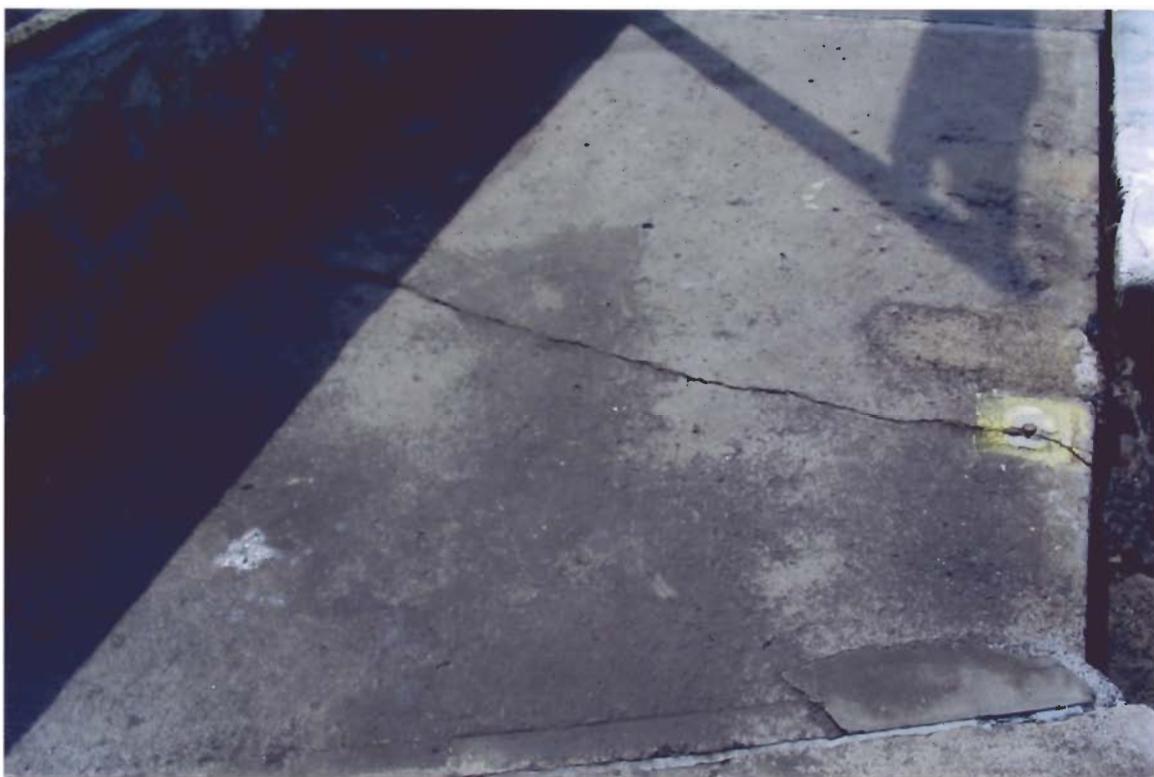
59

Loading Dock No. 4 -
Slab cracks throughout

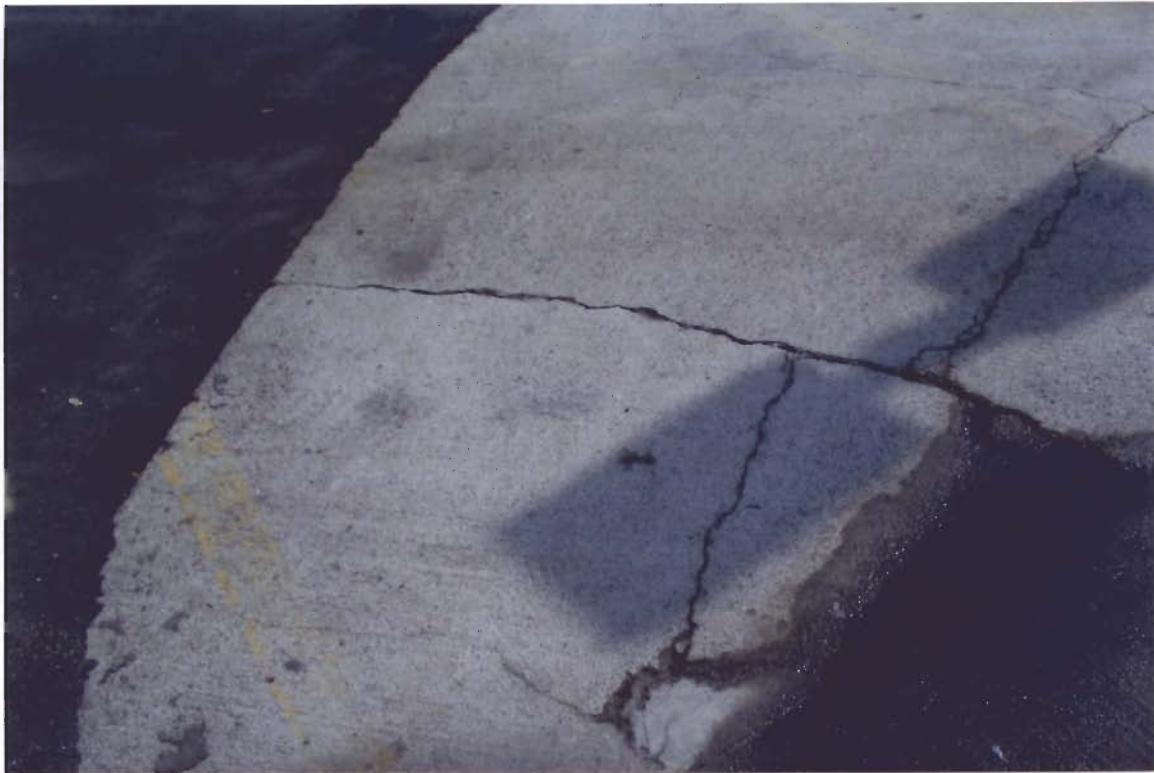
60

Loading Dock No. 4 -
Slab cracks throughout

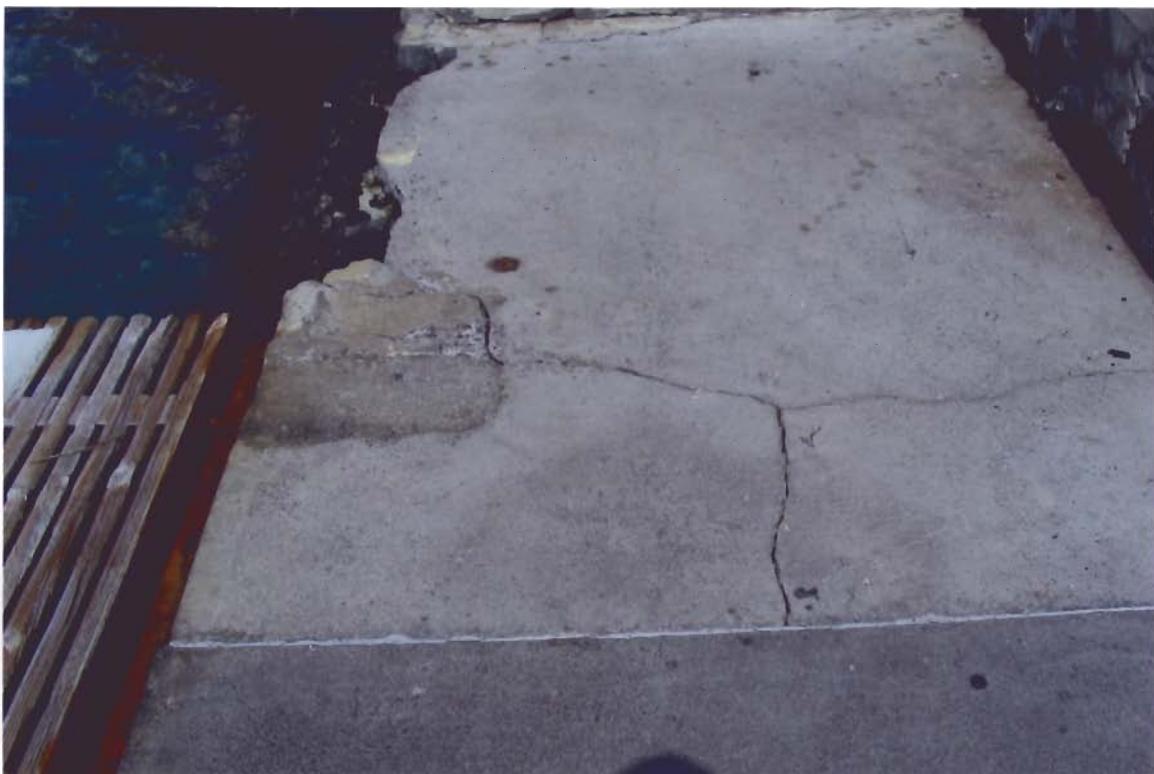
61

Loading Dock No. 4 -
Slab cracks throughout

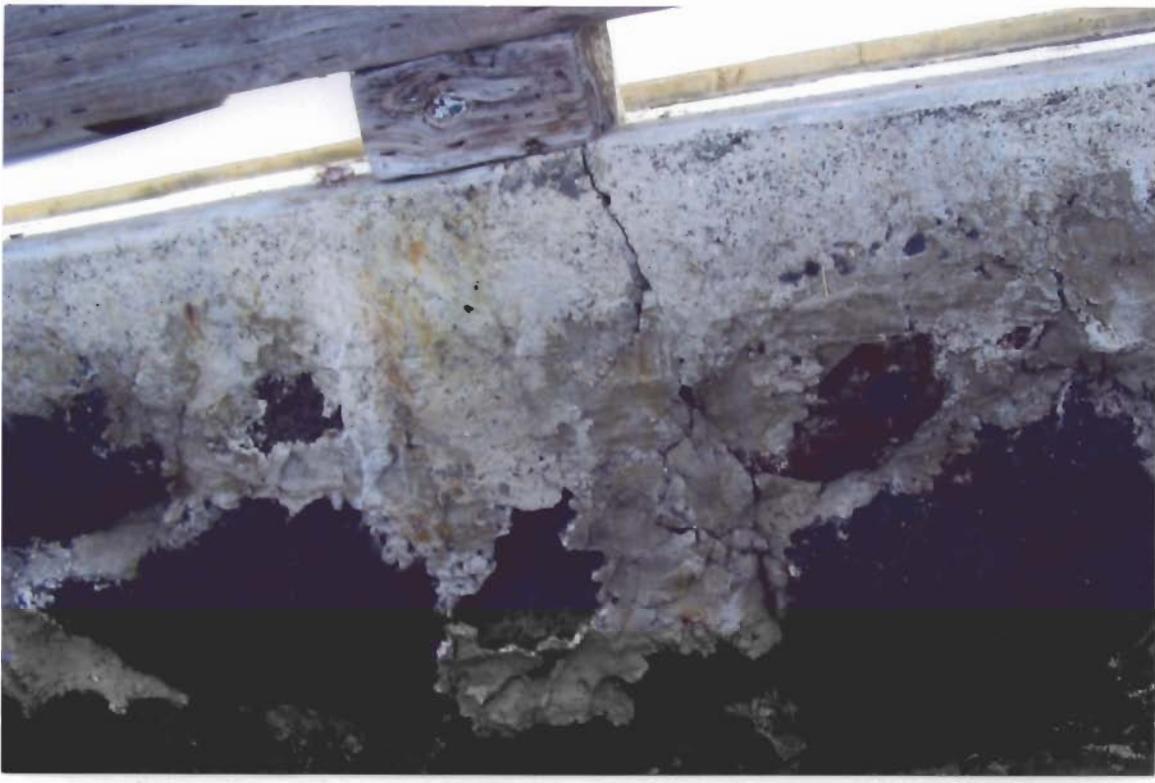
62

Crack CRM walls throughout
along Loading Dock No. 4
